#### **4.4.7 Curing Temperature Results**

## 5. FIELD TESTING

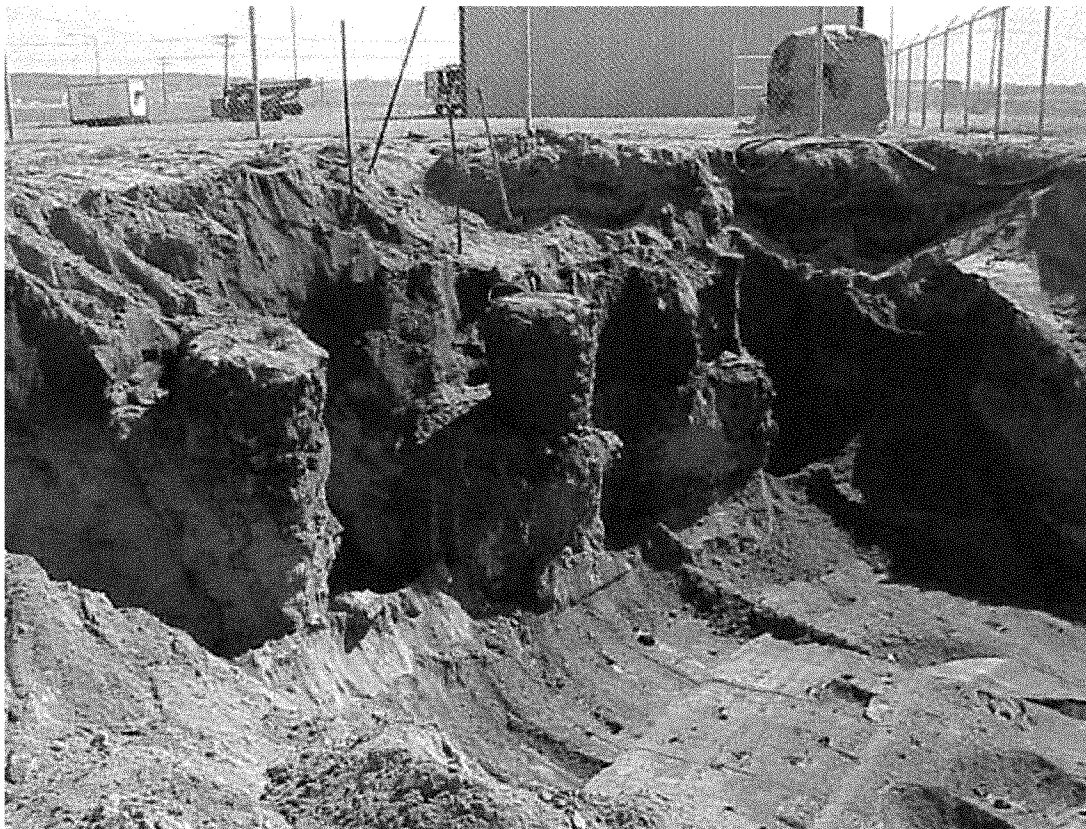
Figure 21. Excavation of the monoliths.

The destructive examination of the columns created under the thrust blocks first involved removing side burden material until the three monoliths were exposed as shown in Figure 21.

The GMENT-12 monolith was isolated on three sides, photographed and measured. The GMENT-12 monolith is on the left side of the photograph shown in Figure 21.

The U.S. Grout monolith also was a cohesive stand-alone piece of the mixtures of soil and grout as shown in Figure 21 on the right. The monolith was irregular shaped in that only 1 full column and 1 half column was grouted prior to filling the block with grout returns. The approximate volume of the column was that 1.2 m (4 ft) of the column had a mean diameter of 109 cm (43 in.) and the other half had a mean diameter of 84 cm (33 in.) which equates to an approximate volume of column of 1806 L (478 gal) of the mixtures of soil and grout. This compares to the amount of grout injected into the column of 532 L (141 gal) which means that the injection process filled 29% of the voids considerably lower than the void filling for the GMENT-12 and TECT HG grouts. It is possible that the relatively low specific gravity (U.S. Grout-1.6, TECT HG-2.16, GMENT-12-1.84) did not impart the same energy to the soil and therefore, the penetration of grout was lower.

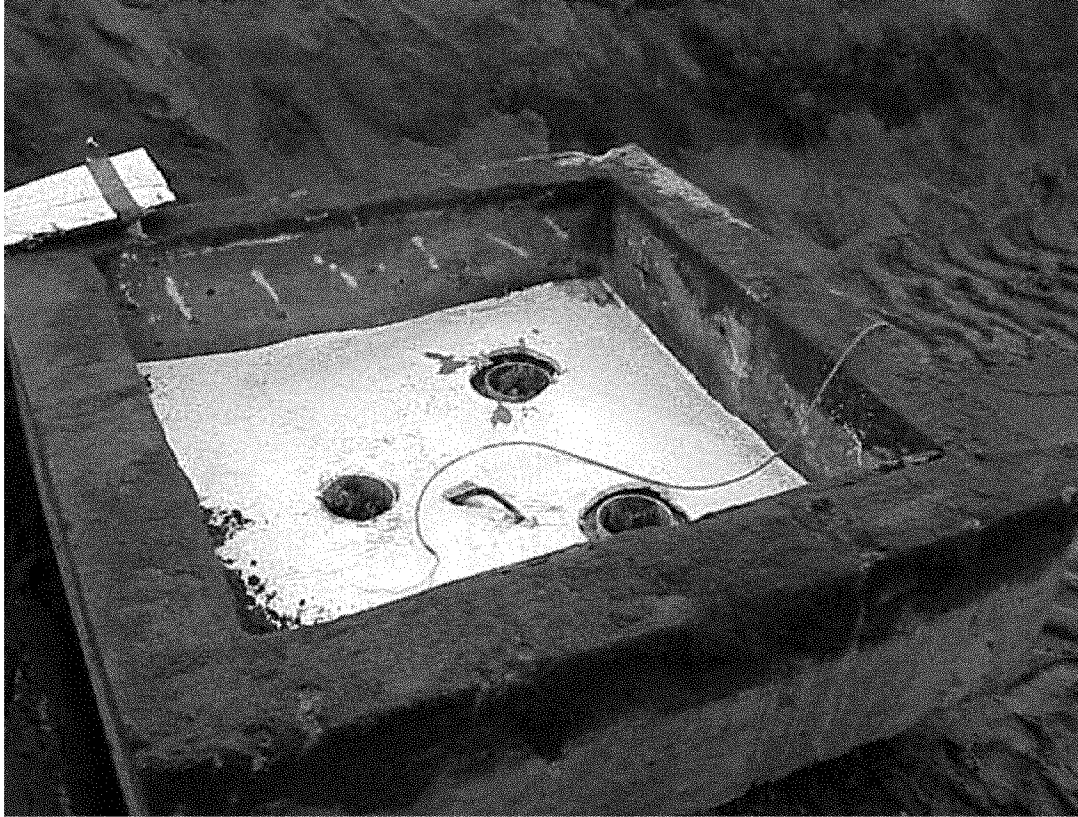
Figure 22. GMENT-12 thrust block (underside showing Styrofoam liner).

For the GMENT-12 grout, however, the entire return came out in one piece, leaving the thrust block empty during the process of rolling the thrust block off the top of the monolith. Figure 22 shows the underside of the GMENT-12 thrust block, with the solid block of cured grout returns basically fallen out of the block during excavation.

It is concluded that generally the blocks are not reusable and that the GMENT-12 grout exhibited the best tendency for not sticking to the Styrofoam. Reuse of the blocks would be a potential for the GMENT-12 grout only.

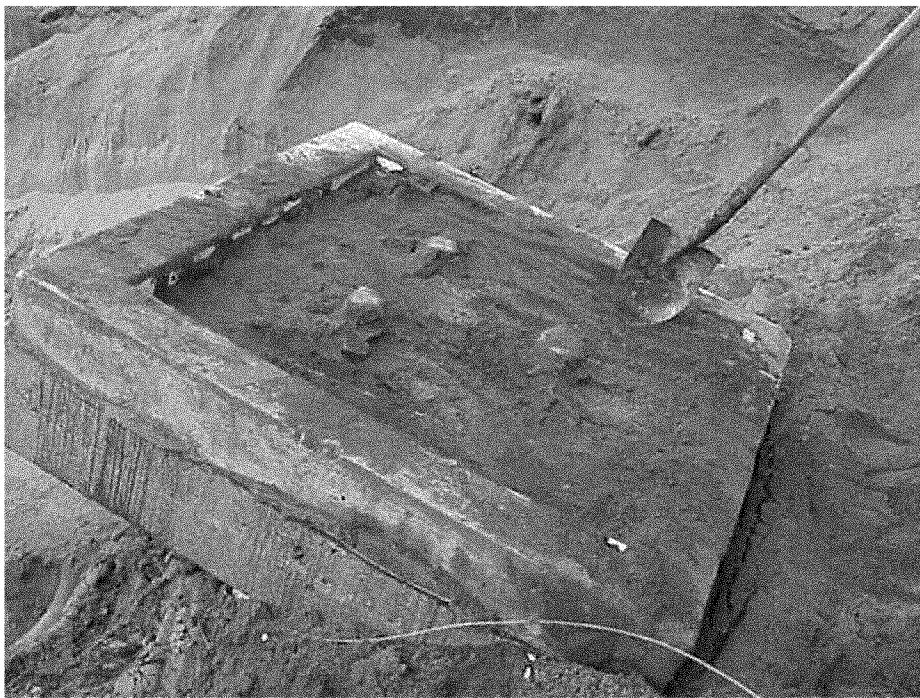
Figure 23. Underside of U.S. Grout thrust block.

This compares to the U.S. Grout thrust block in which the entire grout return not only is stuck to the Styrofoam but the block is confirmed full of cured grout (Figure 23).

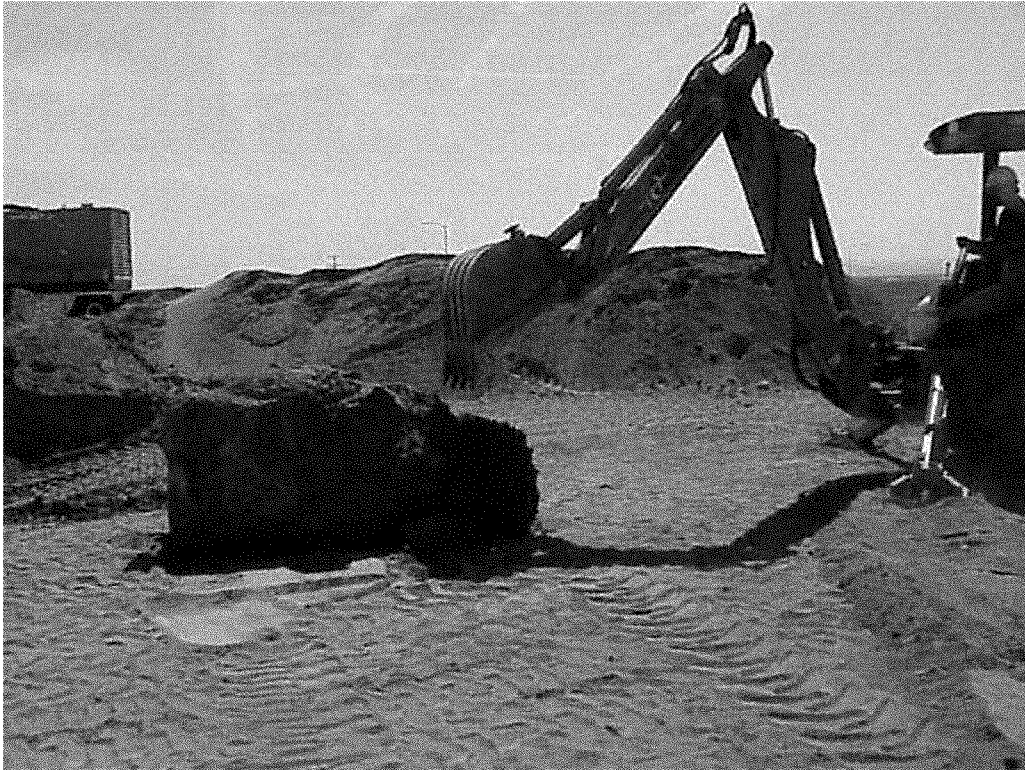
Figure 24. GMENT-12 monolith removed as one piece from the pit.

An attempt was made to break up the monolith using a standard backhoe bucket by raising the bucket above the monolith about 60 cm (2 ft) and striking the monolith. Only small fragments could be obtained after repeated blows, suggesting a strong cohesive monolith (Figure 24).

Using the front-end loader, the monolith was completely removed in one stand-alone piece of the mixtures of soil and grout. The monolith was measured at 2.4 m (8 ft) high by roughly 1.2 m (48 in.) in diameter. This represents a volume of 2,838 L (751 gal), and 1,360 L (360 gal) of grout was injected with 181 L (48 gal) of returns, or a net 1,179 L (312 gal) into the monolith. This equates to a void filling of 41%.

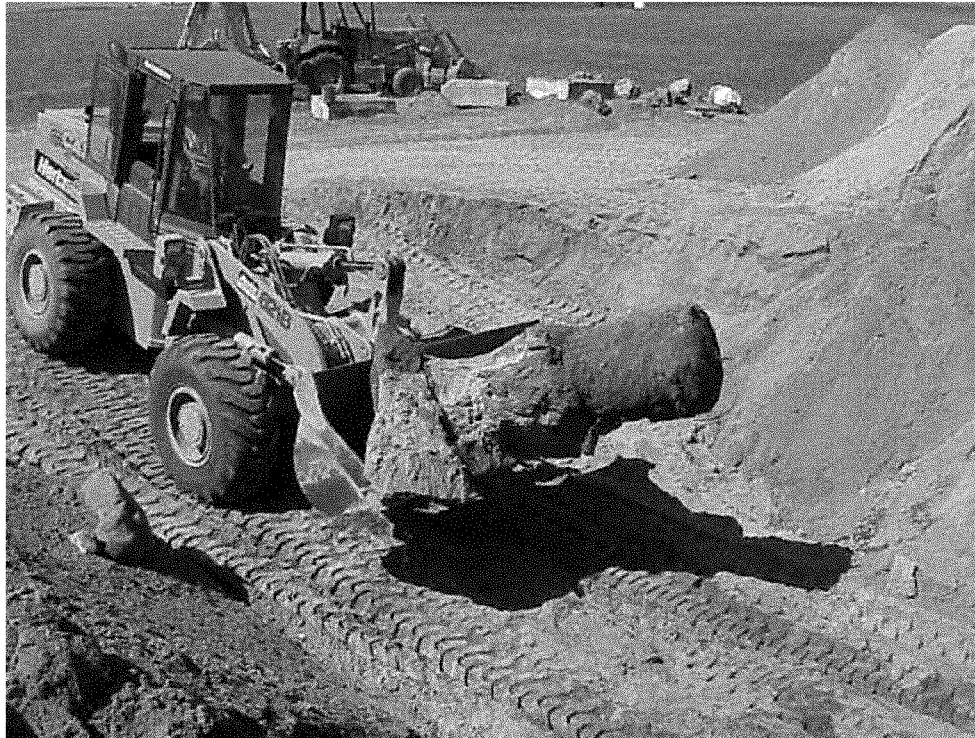
Figure 25. TECT HG monolith being moved as one piece.

The monolith created by the injection of TECT HG grout in a triplex column was a solid cohesive stand-alone monolith as shown being moved out of the pit in Figure 25.

The dimensions of the monolith averaged about 109 cm (43 in.) throughout the length of 2.38 m (7 ft 10 in.) with a reduced section or ledge in the top portion caused by running out of TECT HG grout during the grouting of the last hole. A total of 1251 L (331 gal) of grout were injected with 355 L (94 gal) of returns giving a net volume injected into the monolith of 895 L (237 gal). The size of this monolith equates to an approximate volume of 1950 L (516 gal) of column. Accounting for an approximately 0.6 m (2 ft) diameter by 0.6 m (2 ft) high reduction in the region not grouted due to running out of grout equates to a void filling of 45% which is in good agreement with the GMENT-12 created monolith. An attempt was also made to break up the stand-alone monolith with the backhoe and after repeated attack, only small chunks could be broken off again suggesting a solid cohesive monolith. The hole created by the polyethylene rod inserted into the TECT HG monolith produced a smooth hole for performing U.S. Bureau of Reclamation packer testing as shown in Figure 26.
